SVHSER16000,  
REVISION: Basic  
DATA RIGHTS: N  
DATE: July 14, 1995

# SPACE STATION WATER PROCESSOR PROCESS PUMP

## Final Report

United Technologies Corporation

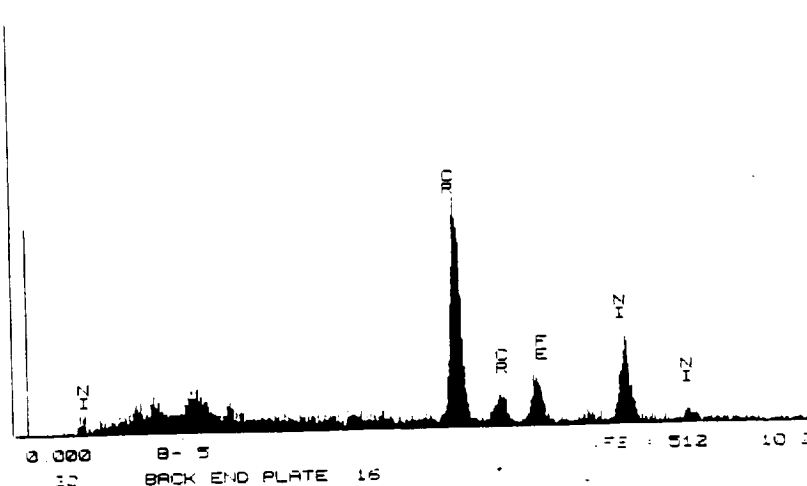
Scanning Electron Microscope (SEM) examination of the bottom plate revealed scoring of the chrome plate and localized deposits rich in nickel and iron. It is likely that chromium was also present, but it was impossible to determine because chromium from the chrome plate on the bottom plate interfered with the chemistry determination. The source of the nickel and iron on this surface is likely the 718 gear (718 is a nickel/chromium/iron alloy). Figure 3 shows the scoring and one area of the nickel/iron rich deposits on the bottom plate. The nickel/iron rich deposits were generally found within the diameter of the root of the gear teeth.

**FIGURE 3:** Bottom plate at the 718 drive gear interface showing scoring and transferred material. The EDX analysis for the indicated area of transferred material is also shown.

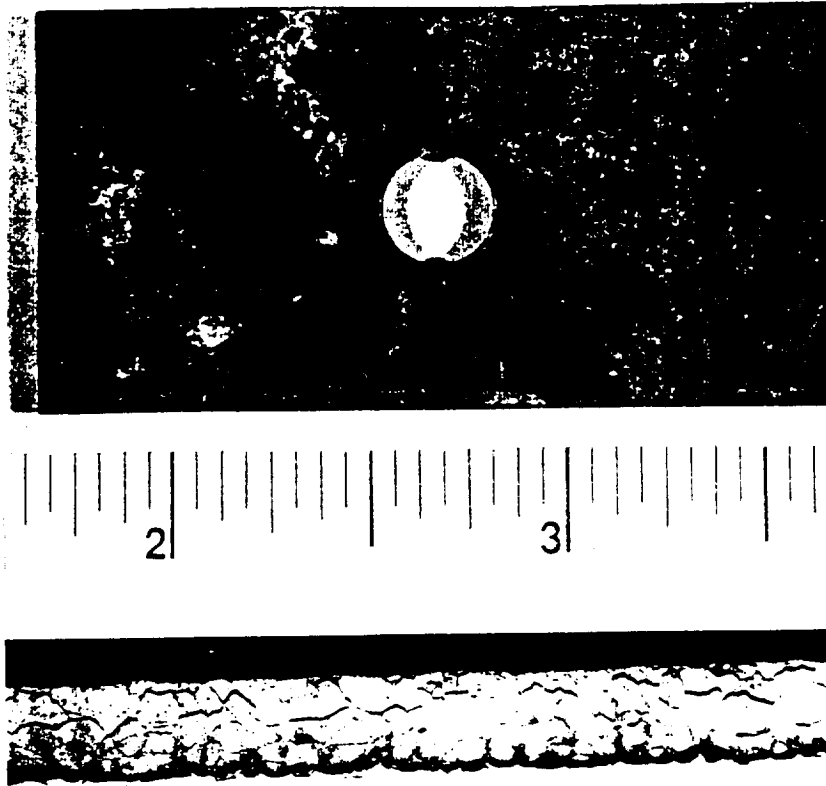
Table 1 summarizes the accelerated corrosion testing. Figures 2 and 3 show macro-photos and cross-sections of the corrosion of the nitrided 17-4 and nitrided A-286, respectively. Significant corrosion and attack into the nitride layer were present on both samples. At the termination of the corrosion testing, the borided 6B showed no evidence

**Figure 3:** Top: Optical photo at 1.5x of the nitrided A-286 sample following corrosion testing.  
Bottom: Optical photo at 200x of the metallographic cross-section of the nitrided A-286 following corrosion testing.

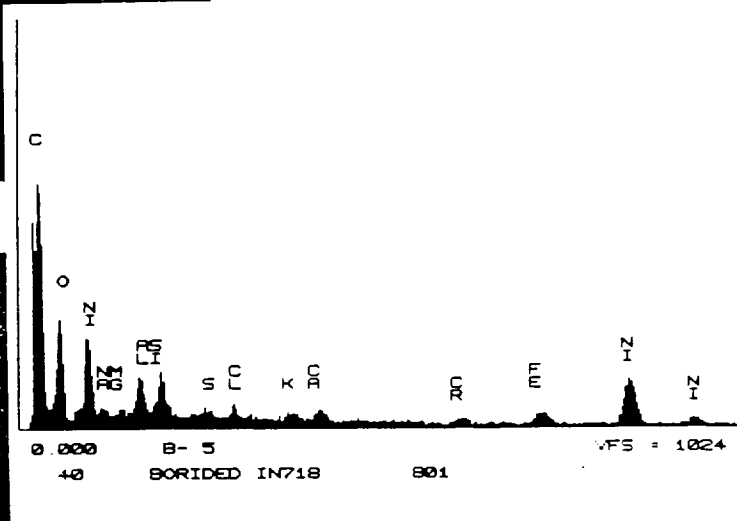
**Figure 6:** SEM photos at 34.8x and 233x of the surface of the over-sized borided 718 gear. An EDX analysis of the deposit material is also shown.

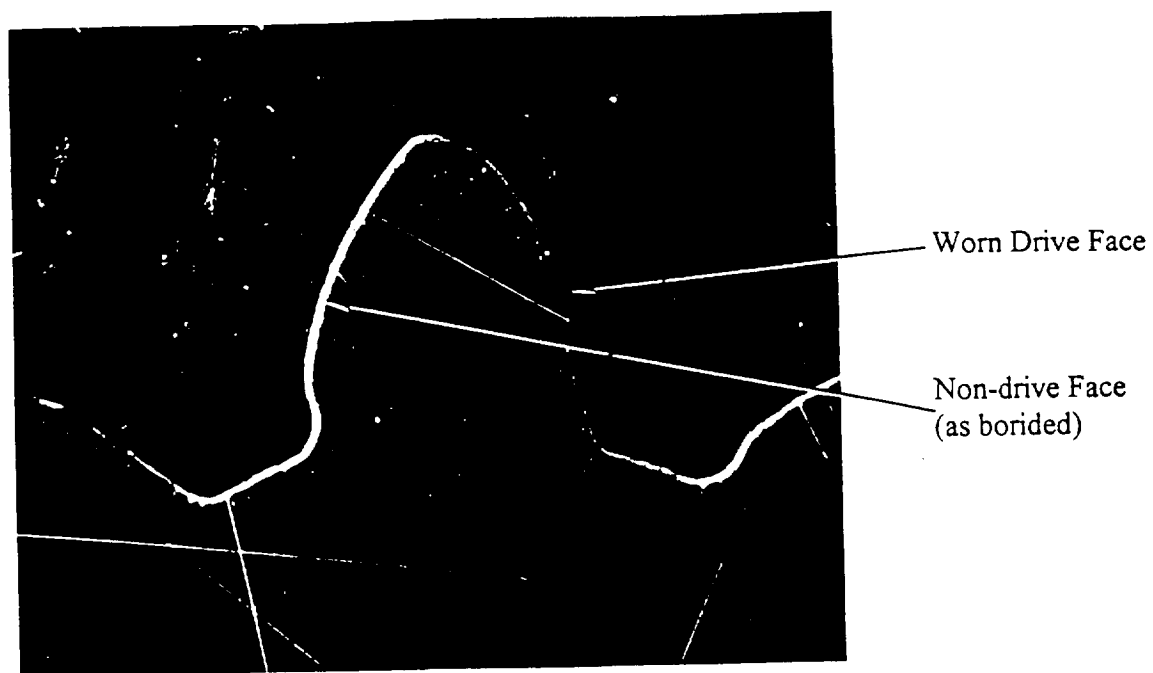
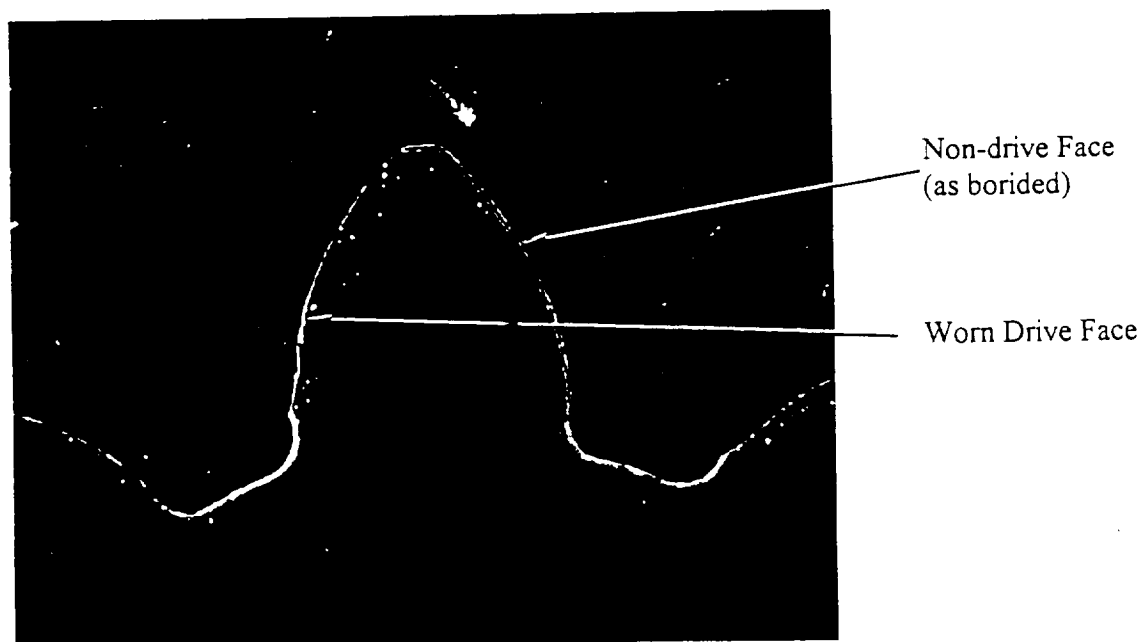
A teardown and inspection was conducted which revealed significant damage to the gear drive faces. This damage was similar to that found on the Inconel 718 gears. Upon the metallurgical examination it was found that the boride layer on the gear drive faces had been removed. Once the Borided surface was removed wear of the gears occurred. The wear/damage to the gears caused an increase to the pump backlash which is believed to have caused the gauge instability and increased pump vibration and noise. This increased backlash also is believed to have caused the decrease in pump performance.

**Figure 3:** Optical photos at 25x of the metallographic cross-sections of the 718 gears.  
TOP: Drive gear. BOTTOM: Driven gear.

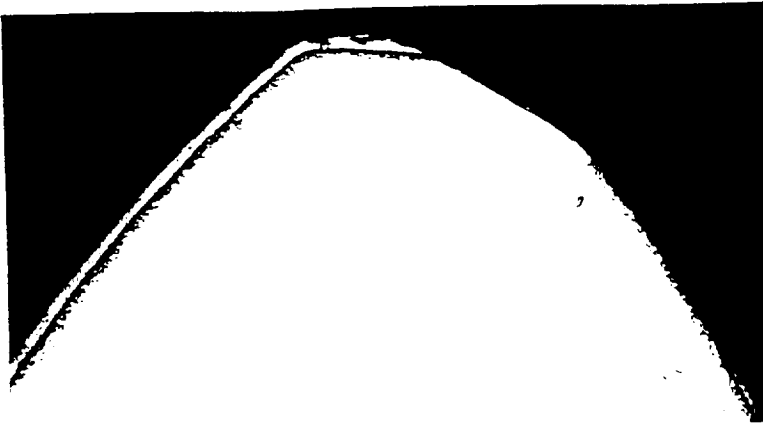
Tip (no evidence of  
boride on drive face)

Pitch Line (some  
evidence of boride  
diffusion zone)

Root (no evidence of  
boride on drive face)

**Figure 4:** Optical photos at 100x of the metallographic cross-section of the 718 drive gear showing the drive face of a typical tooth.

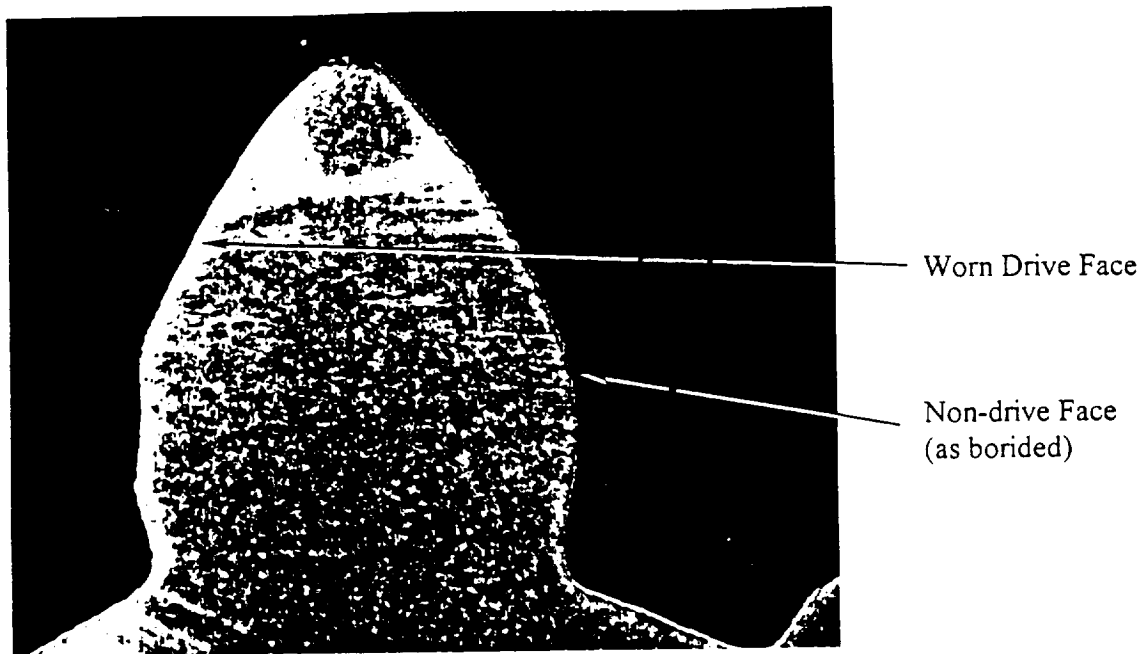
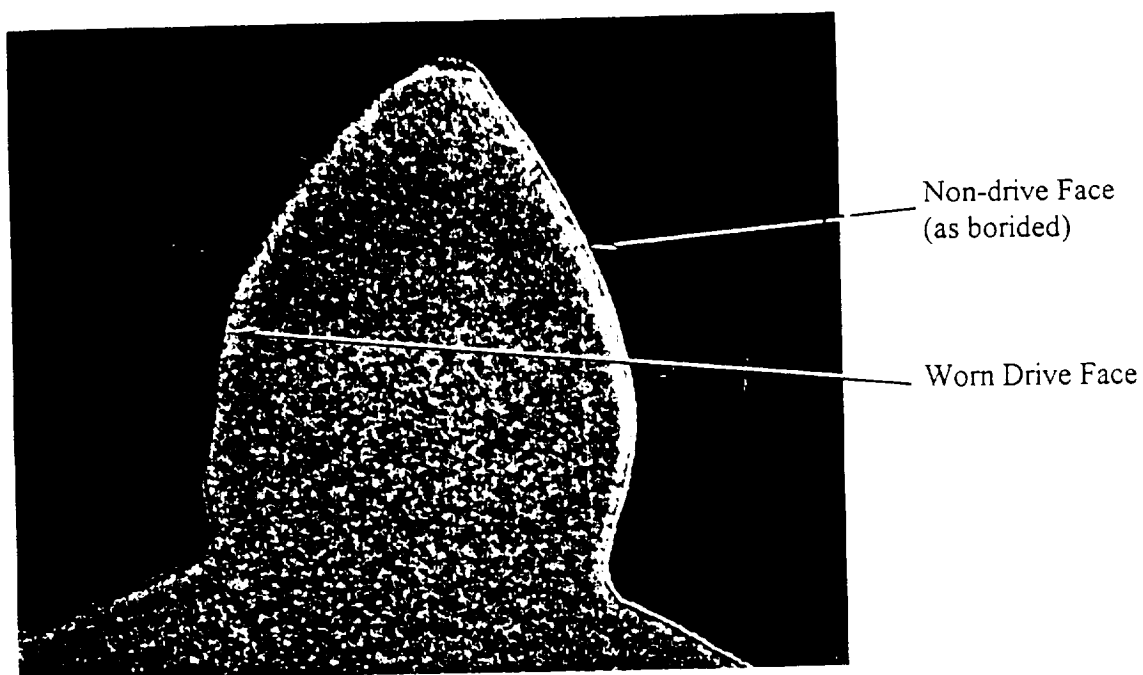
**Figure 9:** Optical photos at 25x of the metallographic cross-sections of the 6B gears.  
TOP: Drive gear.      BOTTOM: Driven gear.
